# Experimental Testing of a 1MW sCO2 Turbocompressor

Logan Rapp Sandia National Laboratories 3<sup>rd</sup> European sCO2 Conference September 20, 2019

David Stapp Peregrine Turbine Technologies

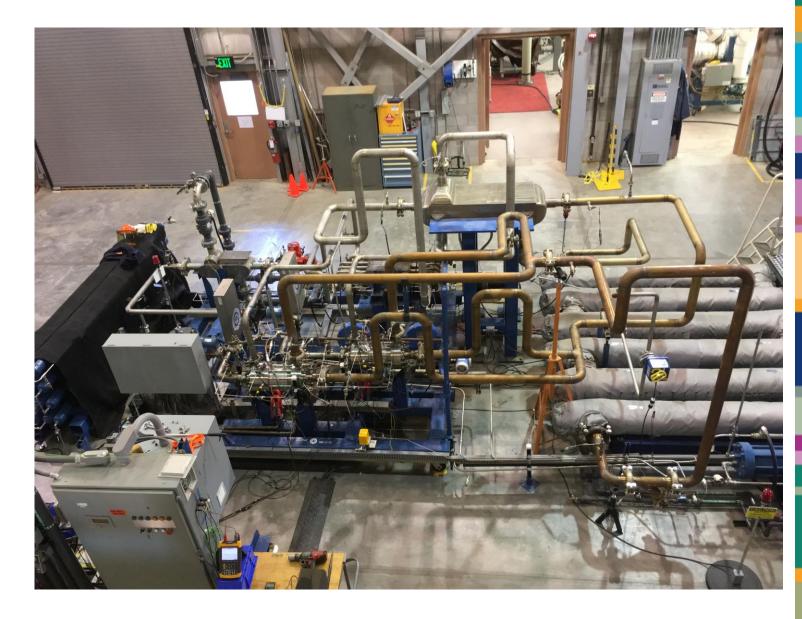
## Recompression Closed Brayton Cycle (RCBC) configuration

#### Commissioned in 2012

Only experimental sCO2 RCBC ever to have been operated

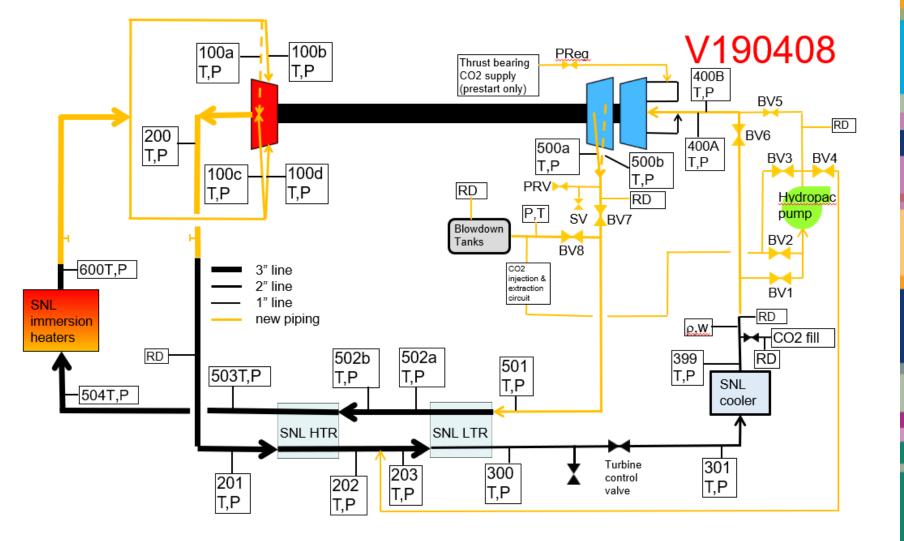
## 4 TurboMachinery Development Platform at SNL

780 kW electric immersion heat

2.3 MW duty High Temp Recuperator

1.6 MW duty Low Temp Recuperator

540 kW water/sCO2 cooler

Hydro-Pac Piston compressor pump

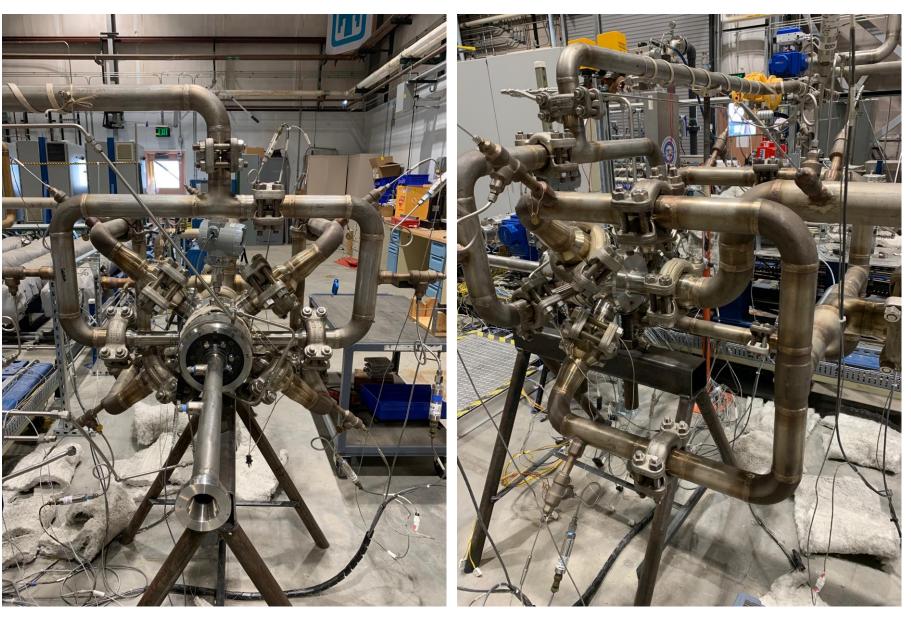
## <sup>6</sup> Peregrine Turbine Technologies Turbocompressor

Design Conditions:

- 118,000 RPM
- 750 C Turbine Inlet (1382 F)
- 42.9 MPa compressor discharge (6222 psi)

Loop Maximum Conditions:

- 538 C Turbine Inlet (1000 F)
- 17.2 MPa compressor discharge (2500 psi)

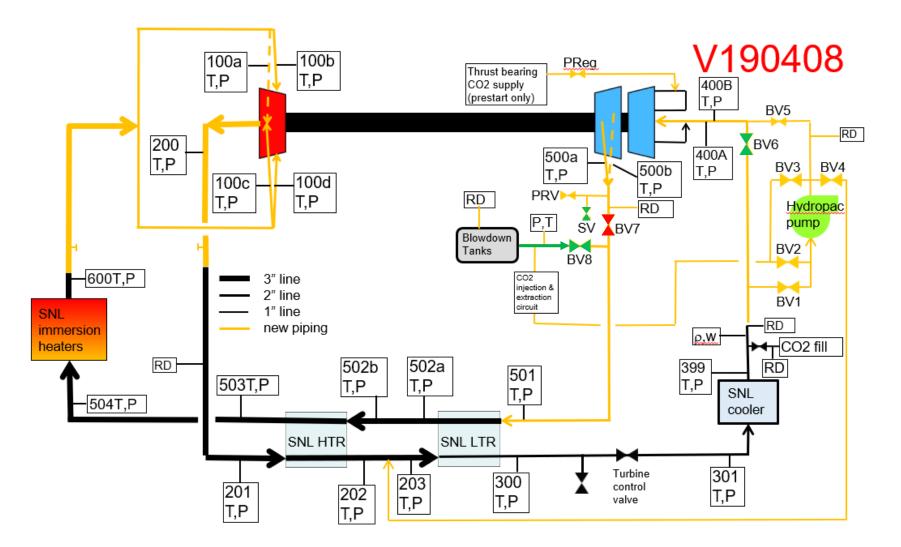
#### 7 Blowdown Start Method

Loop is preconditioned using Hydropac

- Compressor inlet above supercritical conditions
- Turbine inlet at approximately target for test

Valve Positions

- BV7 is closed
- BV8 and SV are opened

Once P500A - P501 > dP\_min:

BV7 is opened and BV8 and SV are closed

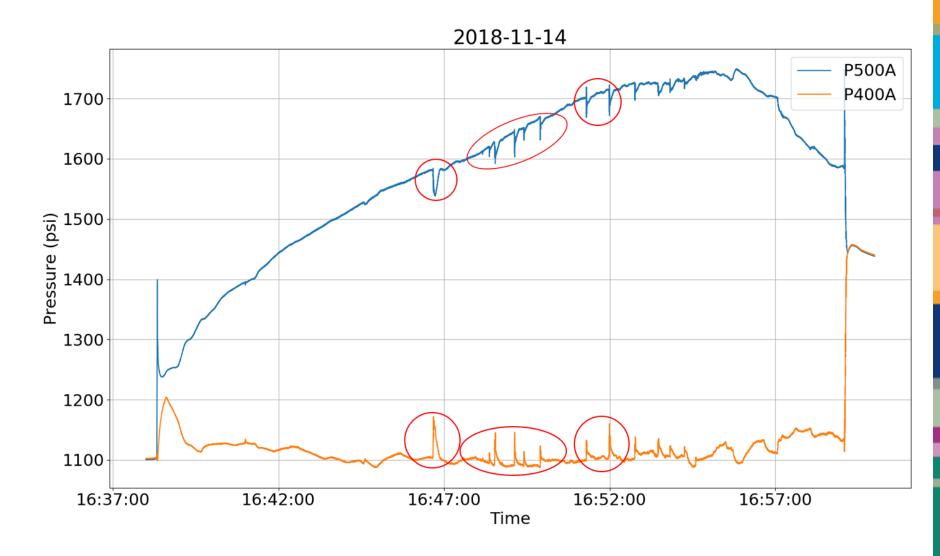
#### 10 Bearing Issues

In Tests #1-3, both the thrust bearing and the radial bearings experienced rubs/failures

Spikes in pressure indicate thrust bearing rubs

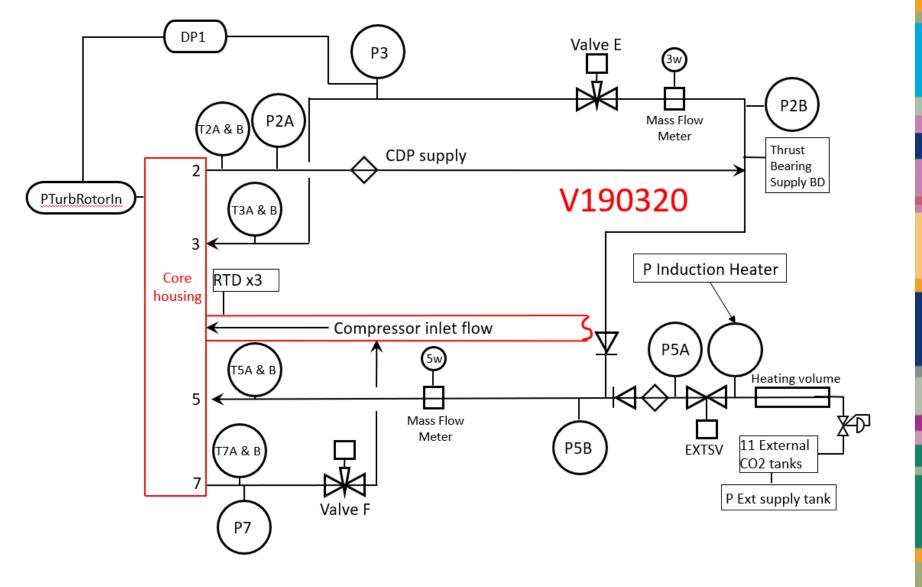
#### 11 Secondary Flows

Valve F regulates venting pressure on aft side of thrust disk rotor – acts as balance piston

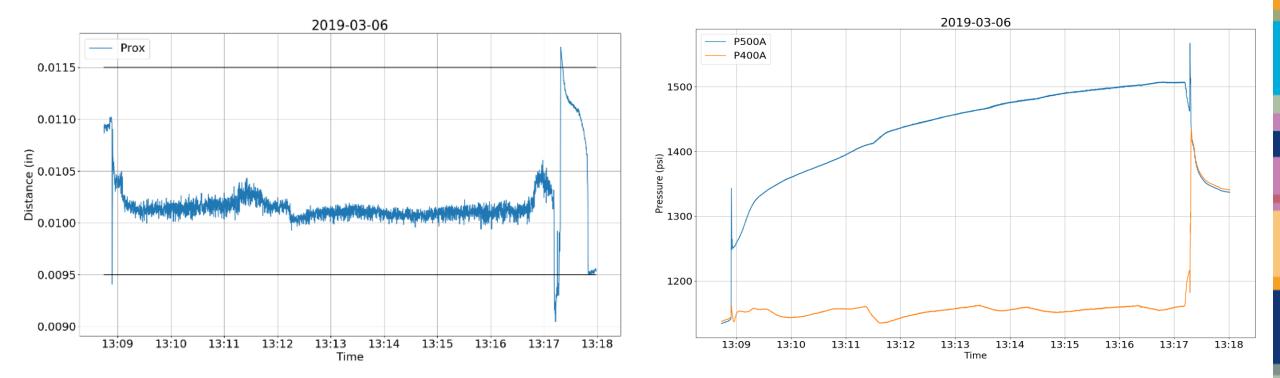
#### 12 Thrust bearing issue resolved

By adjusting Valve F and the TCV the force on the rotor was balanced.

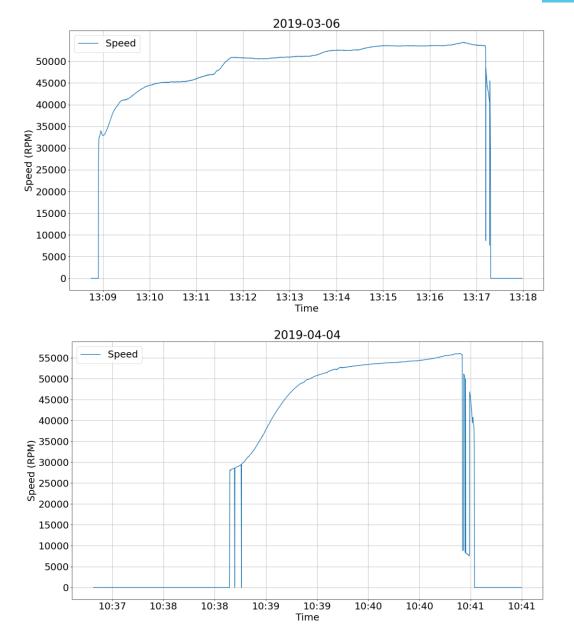
#### 13 Radial Bearing Issues

In all tests (except #7 - 8 hr test), the turbine end radial bearing failed

Possible causes of failure:

- Blowdown start
  - Reduce blowdown pressure
- Critical speed causing rotor instability
  - Physical evidence of bearing failure shows yielded foils at a specific clocking; not indication of rotor instability
- Radial load caused by non-uniform turbine inlet conditions
  - Resolved with instrumentation

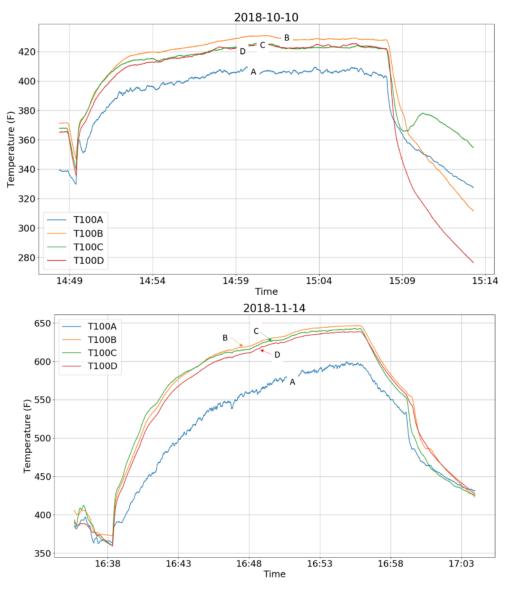
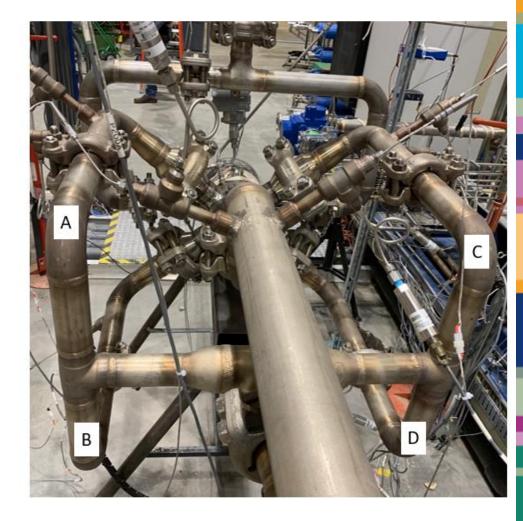
#### 14 **Turbine Inlets**

Leg "A" was consistently lower temperature than the other 3

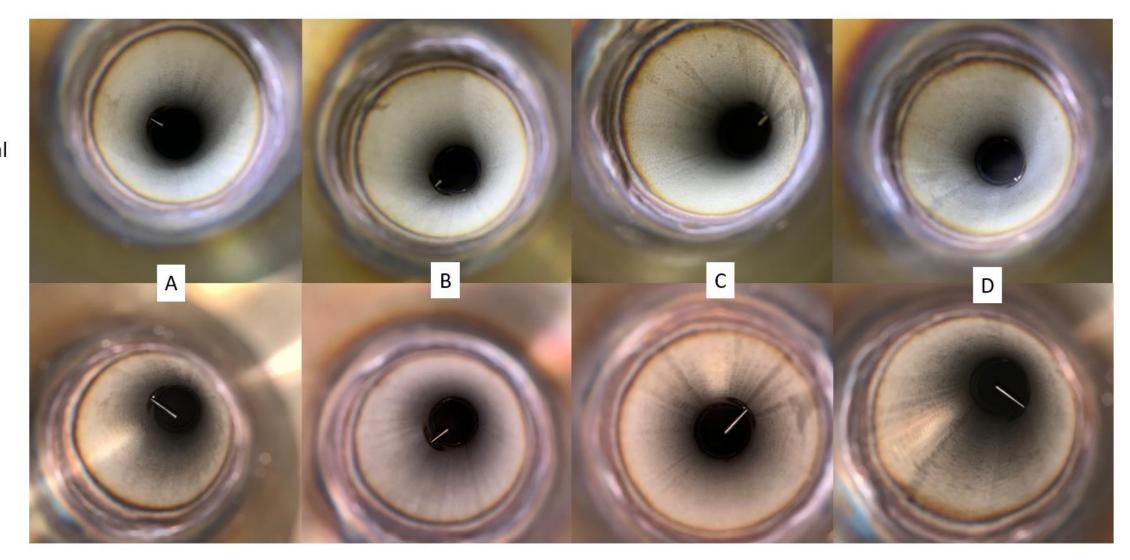
## <sup>15</sup> Original and New Turbine Inlet RTD insertions

Original

New

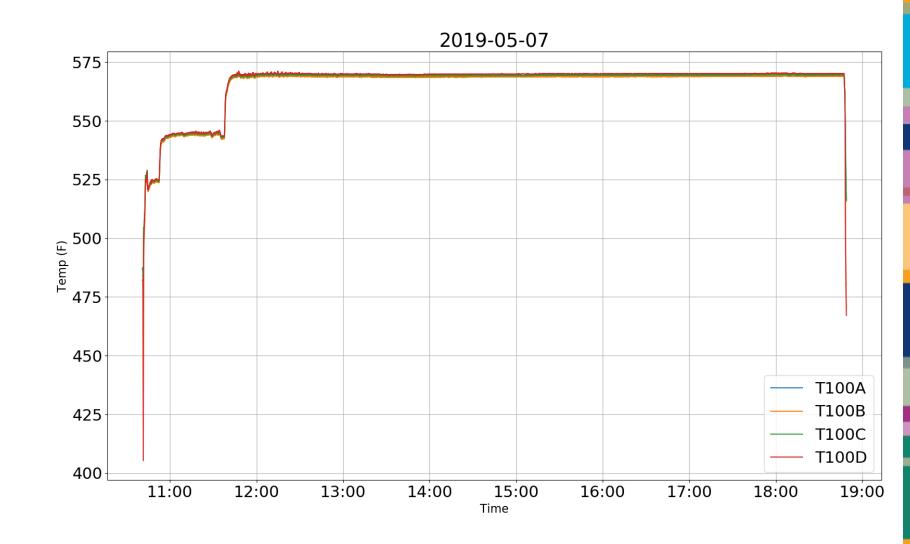
#### <sup>16</sup> **Turbine Inlet Temp with new Insertion depth**

No difference in centerline temperature of turbine inlets

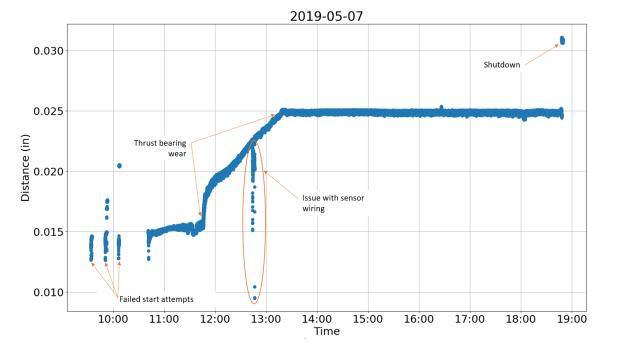
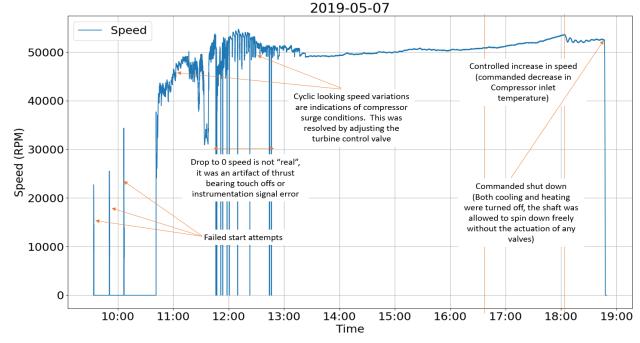
#### <sup>17</sup> Increased L/D of aft radial bearing

The aft radial bearing length/diameter ratio was increased to increase load capacity and the damping of the bearing

Start Number	Turbine Inlet Temp (F)	Blowdown Pressure (psi)	Outcome
1	460	1330	Unsuccessful
2	500	1360	Unsuccessful
3	525	1425	Unsuccessful
4	550	1450	Successful
