Practical Challenges and Failure Modes During Fabrication of Haynes 230 Micro-Pin Solar Receivers for High Temperature sCO₂ Operation

P. S. McNeff, B. K. Paul, O. N. Dogan, K. A. Rozman,
S. Kissick, H. Wang, M. K. Drost and B. M. Fronk

3rd European Supercritical CO₂ Conference

Paper # 2019-sCO₂.eu-157

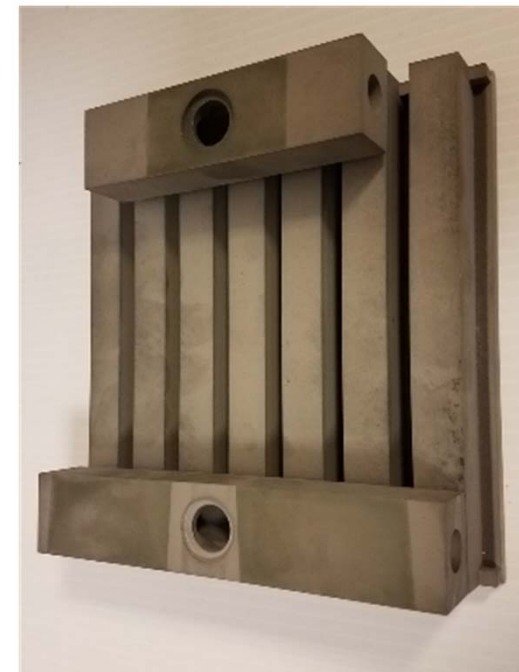
Step	Description
1	Ramp to 950 °C @ 5 °C per minute
2	1 st Hold: 950 °C for 1.5 hours
3	2 nd Hold: 1195 °C for 2.5 hours
4	Cool to 1100 °C (2 °C per min) in 1.5 mbar Argon
5	3 rd Hold: 1100 °C for 3.5 hours

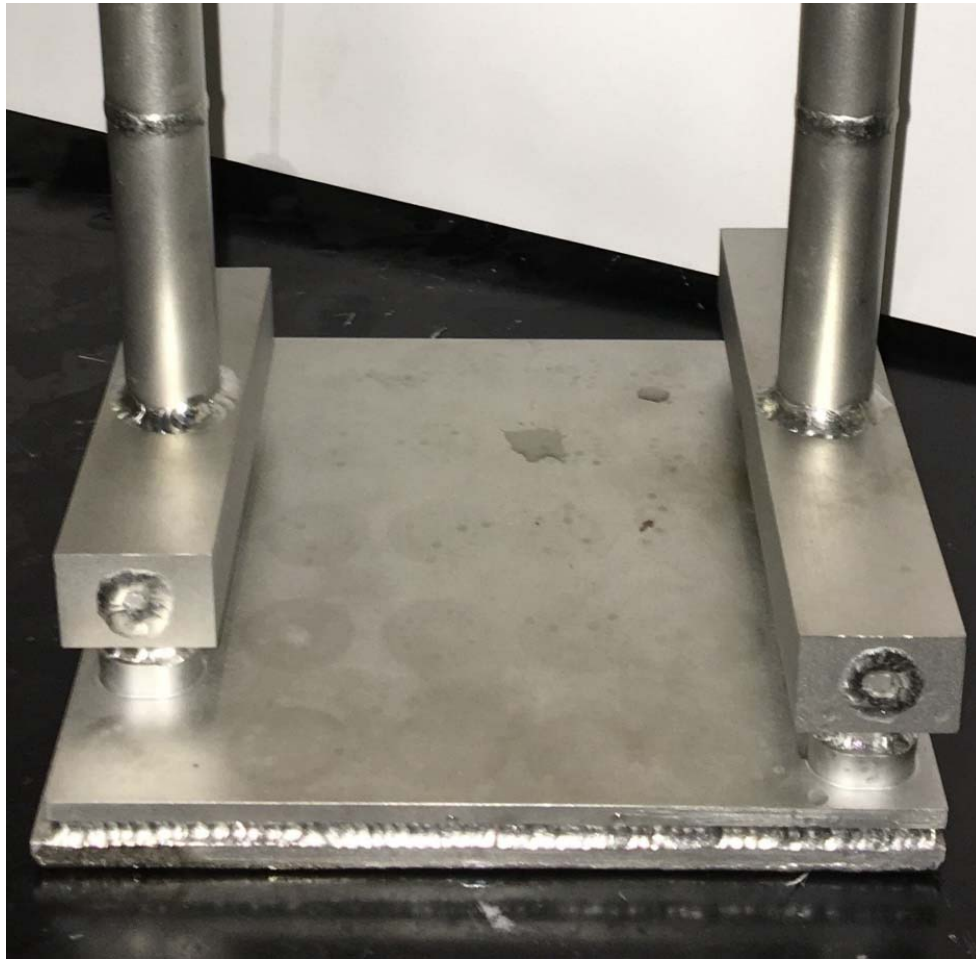
Proof Pressure Test

$$P = 1.3 \cdot MAWP \cdot \frac{\sigma_T}{\sigma_D}$$

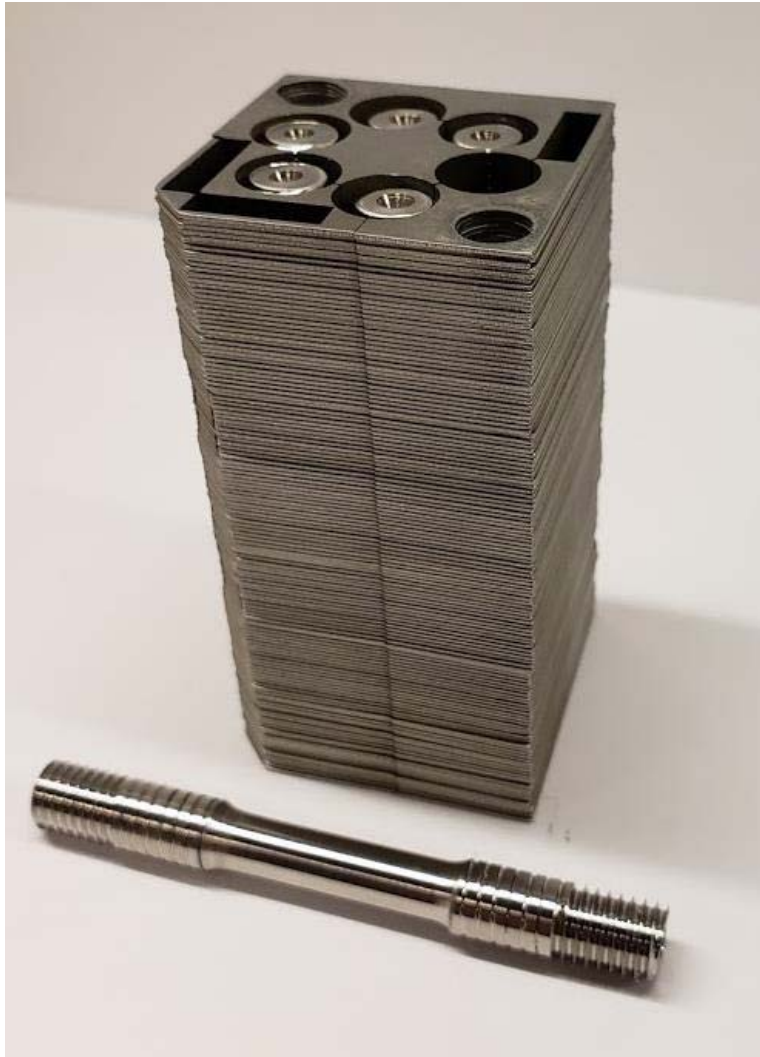
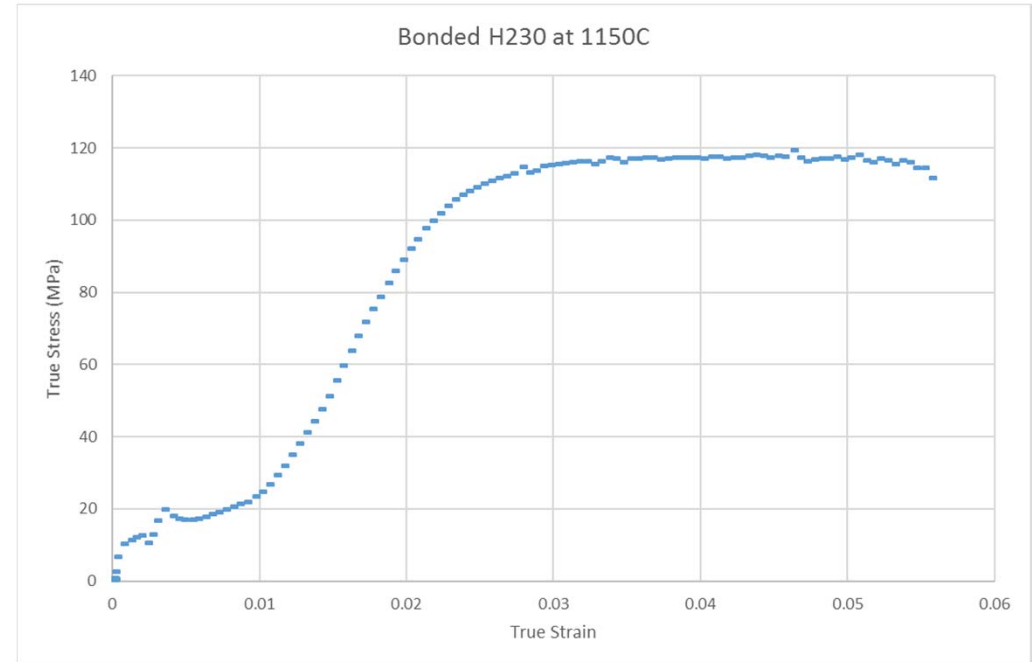
Diffusion Bonding

- Concerns with Boron as MPD for TLP due to fast diffusion
- Move to solid diffusion bonding with and w/o nickel interlayer
- Solid joint at 1150 °C
- Good joint yield/ductility at 720 °C

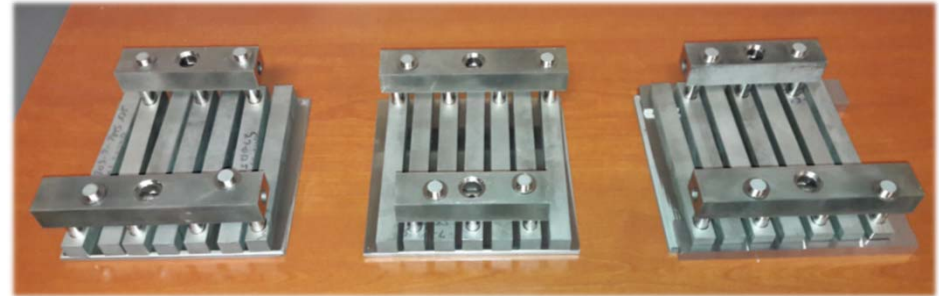
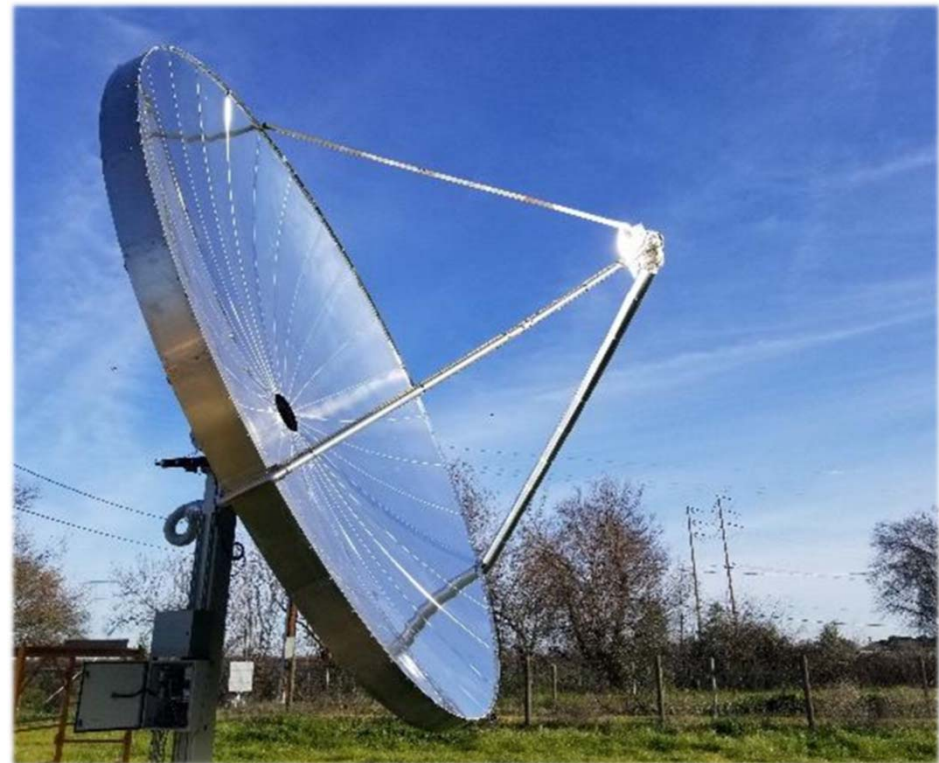
Looking Forward

- Pathway to megawatt scale demonstrated
- Modular concept advantageous
 - Tailored receiver design
 - Manufacturability
- Physical test article designed and fabricated
- On-sun testing at UC-Davis in Q4 2019
